Comparative Study of Two Different Tooth Restorative and Finishing/Polishing Techniques, and the Post-Restorative Impact

Brooke Wilder-Corrigan¹, Jacob Tuft¹, Roberto Lara¹, Ashley Chang², Pam Van Ry², Josue D. Gonzales Murcia³, Claudia M. Tellez Freitas¹, David S. Howard¹, and Katherine Velasco¹

¹Roseman University of Health Sciences, College of Dental Medicine, South Jordan, UT, USA

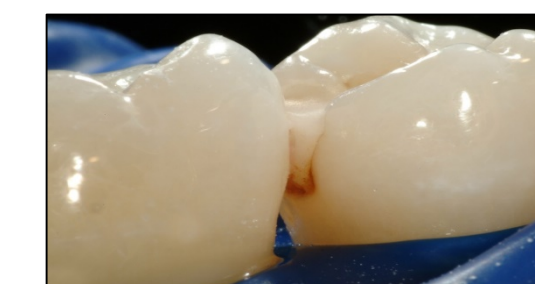
Figure 3. Staining and biofilm accumulation along the DO margins of a composite resin restoration. Phase 2 of this study will analyze biofilm colonization on traditional and modern restorations with the intent on discovering how biofilm may impact resin failure rates.
