# Comparative Study of Two Different Tooth Restorative and Finishing/Polishing Techniques, and the Post-Restorative Impact

Brooke Wilder-Corrigan<sup>1</sup>, Jacob Tuft<sup>1</sup>, Roberto Lara<sup>1</sup>, Ashley Chang<sup>2</sup>, Pam Van Ry<sup>2</sup>, Josue D. Gonzales Murcia<sup>3</sup>, Claudia M. Tellez Freitas<sup>1</sup>, David S. Howard<sup>1</sup>, and Katherine Velasco<sup>1</sup>

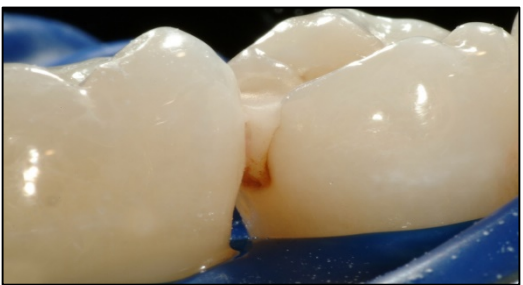
**Figure 3.** Staining and biofilm accumulation along the DO margins of a composite resin restoration. Phase 2 of this study will analyze biofilm colonization on traditional and modern restorations with the intent on discovering how biofilm may impact resin failure rates.
